LIGHTNING PROTECTION OF THE FOKKER 100 CFRP RUDDER.

A.J.M. Ruiter,  
Fokker Space & Systems B.V.,  
(formerly of Fokker Aircraft Corporation),  
Amsterdam,  
Holland.

ABSTRACT

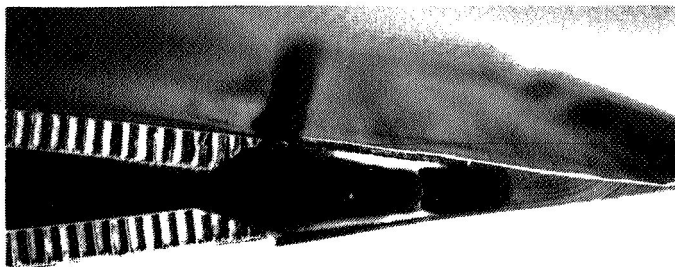
Figure 8A.

Before testing it was decided to add four rivets to one side of the adhesively bonded trailing edge (lower part of figure 8A). This was done at the request of the design office. They estimated that four rivets at the adhesively bonded trailing edge would be sufficient to conduct the simulated lightning currents. This in order to obtain a configuration with the lowest possible weight penalty. After being submitted to the simulated lightning current wave form, the adhesively bonded trailing edge was delaminated. In-house investigations revealed later that the trailing edge was delaminated over more than 75% of the cross section of its connection to the skin panel (upper part of figure 8A).

The trailing edge connection provided by four rivets was also delaminated, although to a much lesser extent. Furthermore, the outer skin plies of the trailing edge at all rivets was also heavily delaminated.

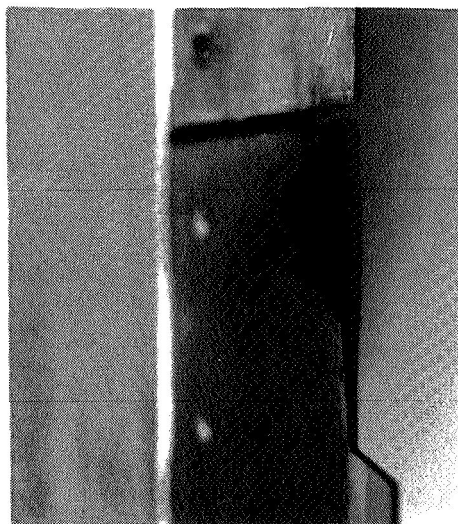
Figure 9A.

The damage to the trailing edge after the simulation of an attachment was limited to local burning of the resin (see figure 9A and 9B). The damage shown is the result after two subsequent tests.

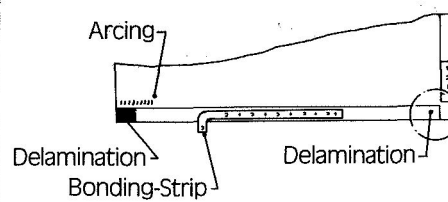
Figure 10A.

The dummy front-spar flanges of both test specimens were delaminated at both ends after the tests (figure 10A and 10B). The dummy rib flange of both test specimens was also delaminated at the end situated at the trailing edge area. The ends of the dummy rib flanges of both test specimens at the bonding jumper connection of the spigot area did not suffer any damage.

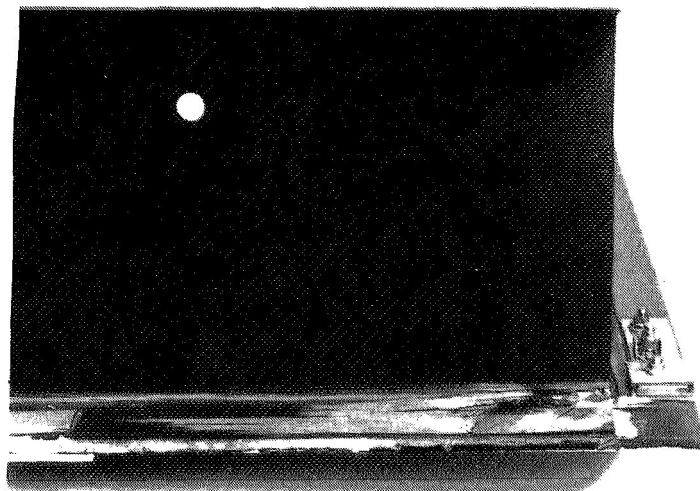
Figure 11A.

After the simulated lightning tests between the bonding jumpers of the middle hinge and the spigot area the end of the front-spar flange was heavily delaminated (figure 12A). At the end of the flange the resin in its "neck" had been vaporized blowing away carbon fibres (figure 11A and 11B). Furthermore, the inner and outer skin of the test specimen was delaminated at the honeycomb connection. This occurred in the region from the inner skin via the CFRP insert at the middle hinge area to the outer skin (figure 12B).
